**Flood Control Project Maintenance
Levee Inspections**

Fall 2015 Levee Maintenance Deficiency Summary Report

Sacramento River Basin

Reclamation District No. 0817 Carlin

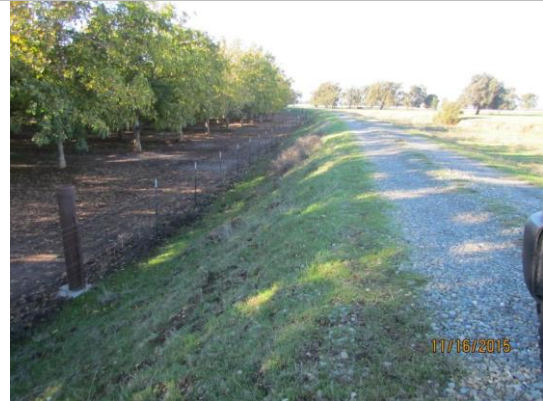
Photo 1 of 1 : FA_2015_RD0817_12_2_20151117_00003.jpg

View of the vegetation on the landward side of the levee looking downstream. Fall 2015.

LM Start	0.00	Rating **	A	Issue No.	3
LM End	3.80	Issue Type +	Ma	Location *	WS
Category	Earthen Levee			GPS Latitude/Longitude	
				Start	End
Item	Vegetation			38.984678 °	39.019703 °
				-121.506107 °	-121.454296 °
DWR ID	DWR_RD0817_01_f _ 2015_3				
Action/Comments					
Control annual grass and weeds on the levee slopes and easements. Inspector Comments: LMA has grazed the slope on the waterward side of the levee.

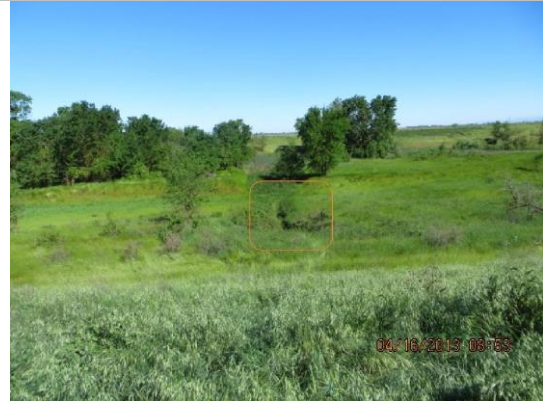
Photo 1 of 3 : UCIP_FA_2015_0290.jpg

Inspector Comments: FS_ID:42685
 DS_ID:18985
 EP_NO: N/A
 FS_HLM: 0.285
 Repair Type: Non-Urgent
 Crossing Status: Found
 UCIP Comments: Dense vegetation on waterward and landward slopes limit visual inspection of potential leaks along pipe alignment. Recommend having owner clear vegetation along slopes.
 FIELD_STRUCT_DESC: 48-inch corrugated metal drainpipe through levee, 23.3 feet below the crown. Flap gate on waterward end.
 FS Date: 04/16/2013

WS- dense vegetation on WS of the levee

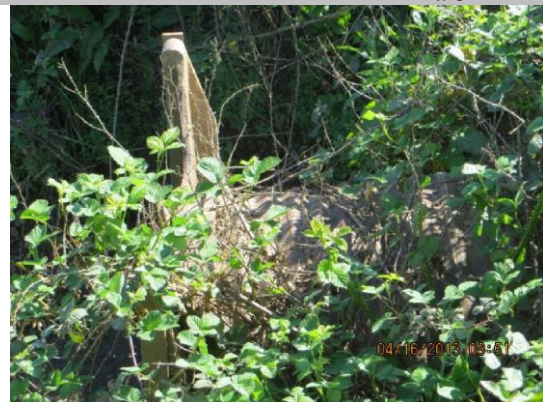
Photo 2 of 3 : UCIP_FA_2015_0291.jpg

WS- CM pipe and flap gate

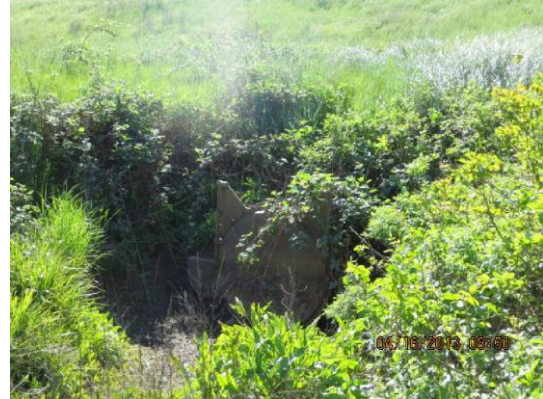
Photo 3 of 3 : UCIP_FA_2015_0292.jpg

WS- pipe, flap gate in dense vegetation on berm

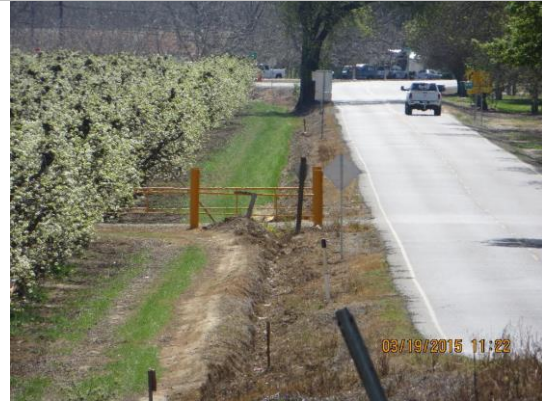
Photo 1 of 2 : UCIP_FA_2015_5832.jpg

LM Start	1.13	Rating **	M	Issue No.	17
LM End	1.13	Issue Type +	En	Location *	WS
Category	Supplemental			GPS Latitude/Longitude	
				Start	End
Item	DWR UCIP Field Study			38.995667 °	38.995667 °
				-121.490981 °	-121.490981 °
DWR ID					
Action/Comments					
Inspector Comments: FS_ID:44084 DS_ID:25088 EP_NO: N/A FS_HLM: 1.13 Repair Type: Non-Urgent Crossing Status: Found UCIP Comments: No permit identified for this crossing. FIELD_STRUCT_DESC: 4-inch steel communication conduit through the levee, 4 feet below levee crown. FS Date: 03/19/2015

Fiberoptic line markers along roadway to south of bridge.

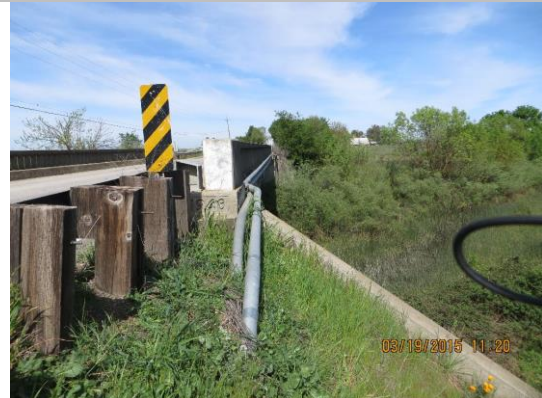
Photo 2 of 2 : UCIP_FA_2015_5833.jpg

Communication conduit visible on upstream side of bridge.

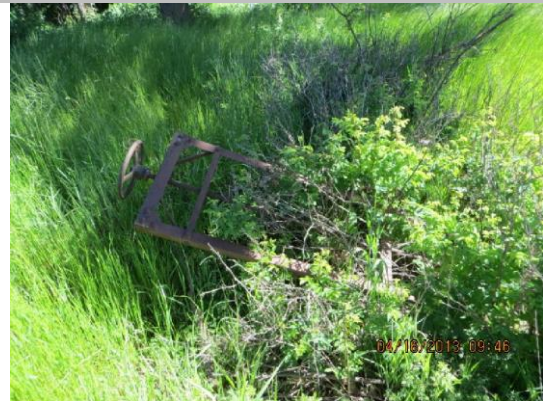
Photo 1 of 2 : UCIP_FA_2015_0293.jpg

LM Start	1.34	Rating **	M	Issue No.	19
LM End	1.34	Issue Type +	En	Location *	WS
Category	Supplemental			GPS Latitude/Longitude	
				Start	End
Item	DWR UCIP Field Study			38.997961 °	38.997961 °
				-121.488455 °	-121.488455 °
DWR ID					
Action/Comments					
Inspector Comments: FS_ID:41153 DS_ID:18987 EP_NO: N/A FS_HLM: 1.343 Repair Type: Non-Urgent Crossing Status: Found UCIP Comments: Damaged slide gate on WS of the levee. Need to contact owner to determine status of crossing. If crossing is no longer in use owner will need to contact CVFPB to comply with Title 23. Dense vegetation on waterward and landward slopes limit visual inspection of potential leaks along pipe alignment. Recommend having owner clear vegetation along slopes. FIELD_STRUCT_DESC: *ABANDONED* 18-inch corrugated metal drainpipe through levee, 14.9 feet below the crown. Slide gate on the waterward end. O&M Manual Sac 146, November 1962. FS Date: 04/16/2013

WS- closer look at damaged slide gate on WS

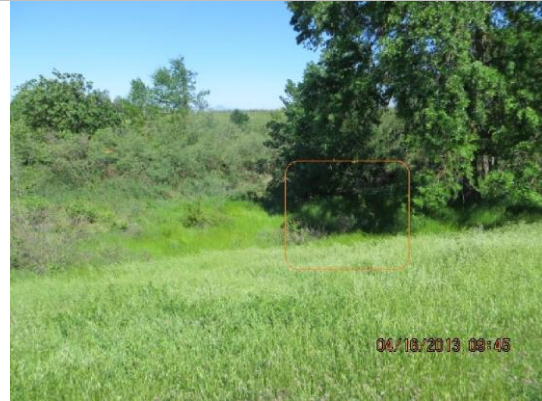
Photo 2 of 2 : UCIP_FA_2015_0294.jpg

WS- overview of WS area

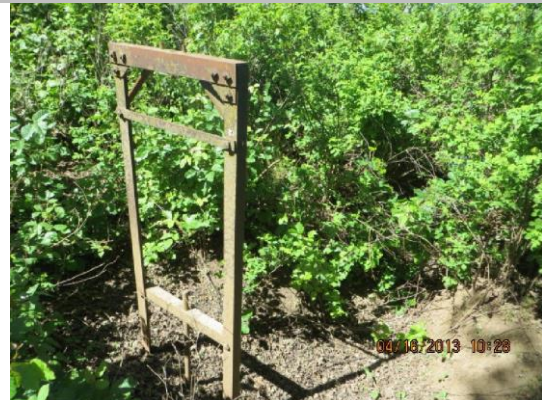
Photo 1 of 3 : UCIP_FA_2015_0295.jpg

LM Start	1.62	Rating **	M	Issue No.	20
LM End	1.62	Issue Type +	En	Location *	WS
Category	Supplemental			GPS Latitude/Longitude	
				Start	End
Item	DWR UCIP Field Study			39.001340 °	39.001340 °
				-121.485740 °	-121.485740 °
DWR ID					
Action/Comments					
Inspector Comments: FS_ID:41157 DS_ID:18988 EP_NO: N/A FS_HLM: 1.62 Repair Type: Non-Urgent Crossing Status: Found UCIP Comments: A buried slide gate on WS of the levee. Need to contact owner to determine status of crossing. If crossing is no longer in use owner will need to contact CVFPB to comply with Title 23. Dense vegetation on waterward and landward slopes limit visual inspection of potential leaks along pipe alignment. Recommend having owner clear vegetation along slopes. FIELD_STRUCT_DESC: *ABANDONED* 18-inch corrugated metal drainpipe through the levee, 14.9 feet below the crown. Slide gate on the waterward end. O&M Manual Sac 146, November 1962. FS Date: 04/16/2013

WS- buried slide gate

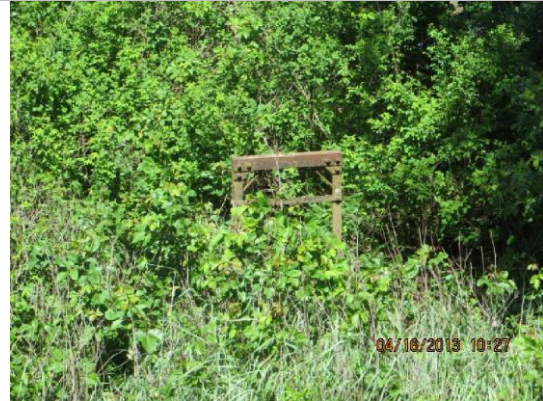
Photo 2 of 3 : UCIP_FA_2015_0296.jpg

WS- slide gate

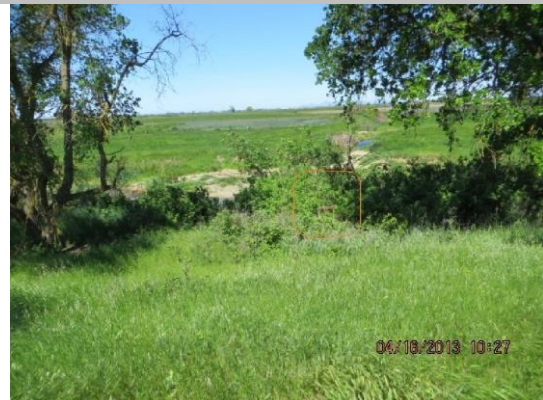
Photo 3 of 3 : UCIP_FA_2015_0297.jpg

WS- overview of WS berm

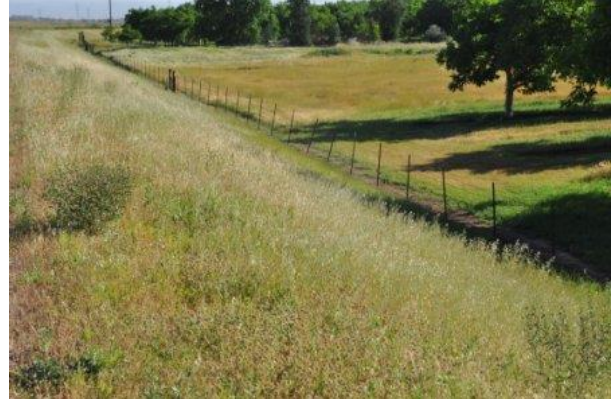
Photo 1 of 1 : FA_2015_RD0817_12_8_20151102_00001.jpg

Wire fence at L/S levee toe.

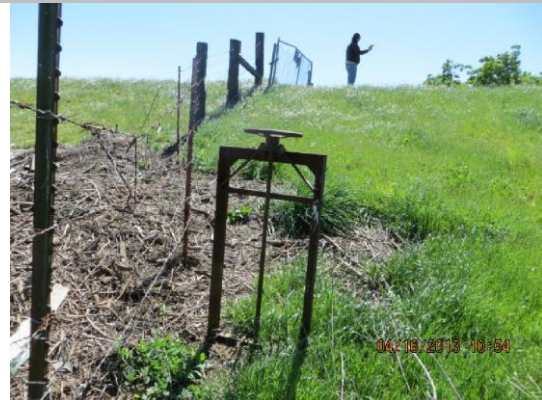
Photo 1 of 1 : UCIP_FA_2015_0298.jpg

Action/Comments					
Inspector Comments: FS_ID:41156 DS_ID:18989 EP_NO: N/A FS_HLM: 2.29 Repair Type: Non-Urgent Crossing Status: Indicator Found UCIP Comments: A buried slide gate found on WS. Need to contact owner to determine status of crossing. If crossing is no longer in use owner will need to contact CVFPB to comply with Title 23. Dense vegetation on waterward and landward slopes limit visual inspection of potential leaks along pipe alignment. Recommend having owner clear vegetation along slopes. FIELD_STRUCT_DESC: Abandoned 18-inch corrugated metal drainpipe through levee, 11.7 feet below the crown. Slide gate on the waterward end. O&M Manual Sac 146, November 1962. FS Date: 04/16/2013

WS- slide gate on levee toe.

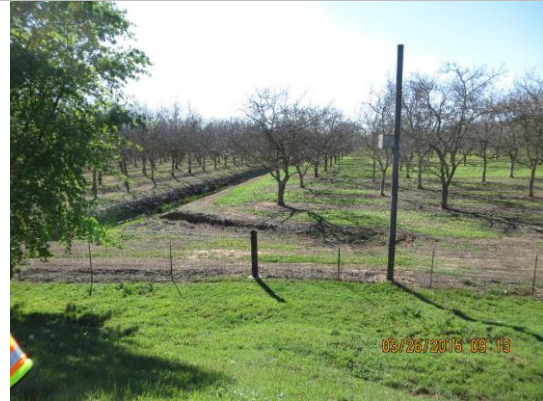
Photo 1 of 3 : UCIP_FA_2015_5778.jpg

Action/Comments					
Inspector Comments: FS_ID:41320 DS_ID:18995 EP_NO: 16193 FS_HLM: 2.96 Repair Type: Non-Urgent Crossing Status: Not Found UCIP Comments: Dense vegetation limits the inspector's visibility to identify signs of pipe failure (leaks) along the waterward and landward slope. Recommend removing vegetation along pipe alignment to conduct proper inspection of structure and appurtenances. FIELD_STRUCT_DESC: Remove (1 of 3 locations) abandoned 18-inch diameter pipeline from the left bank levee of Dry Creek. (App. No. 16193) FS Date: 04/16/2013

LS of pipe buried but alignment would place LS outlet just left of telephone pole on LS toe.

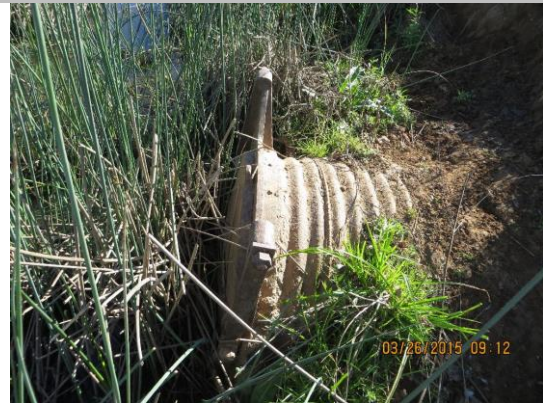
Photo 2 of 3 : UCIP_FA_2015_5779.jpg

Pipe and flapgate visible on WS toe.

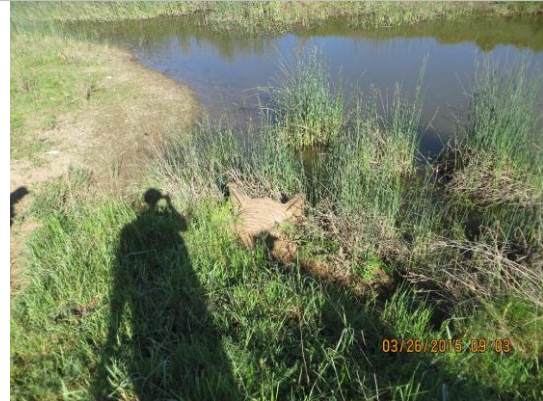
Photo 3 of 3 : UCIP_FA_2015_5780.jpg

Pipe and flapgate visible on WS toe.

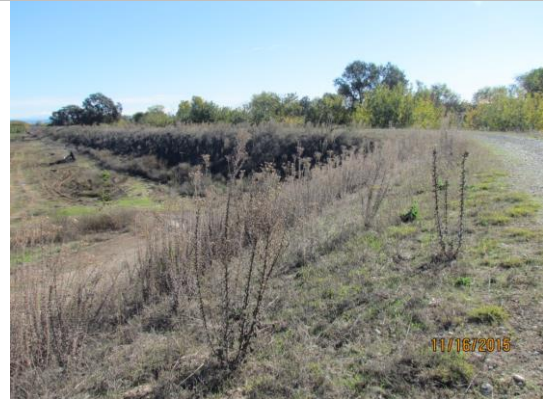
Photo 1 of 1 : FA_2015_RD0817_13_3_20151117_00007.jpg

View of the vegetation on the landward side of the levee looking upstream. Fall 2015.

LM Start	0.10	Rating **	M	Issue No.	7
LM End	0.63	Issue Type +	Ma	Location *	WS
Category	Earthen Levee			GPS Latitude/Longitude	
				Start	End
Item	Vegetation			38.983974 °	38.984959 °
				-121.504688 °	-121.494852 °
DWR ID	DWR_RD0817_02_f_2015_7				
Action/Comments					
Control annual grass and weeds on the levee slopes and easements.

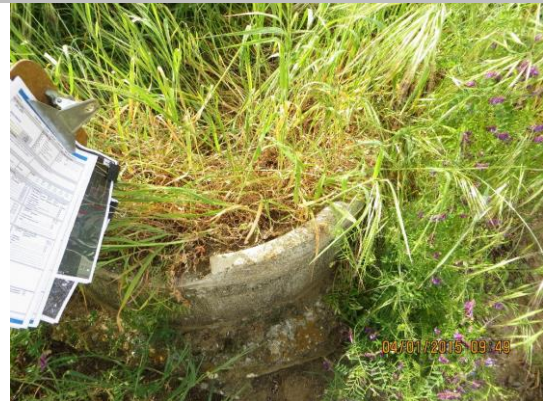
Photo 1 of 3 : UCIP_FA_2015_5829.jpg

Concrete standpipe visible on lower slope of LS toe.

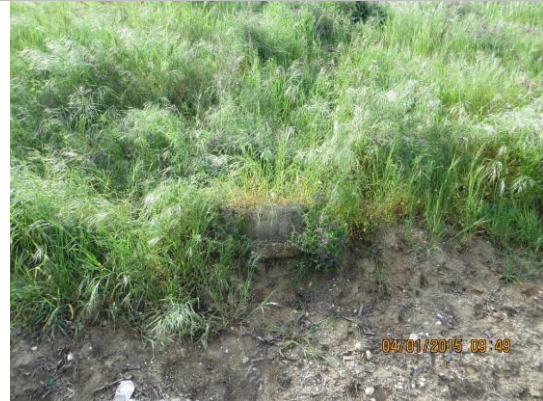
Photo 2 of 3 : UCIP_FA_2015_5830.jpg

Concrete standpipe visible on lower slope of LS toe.

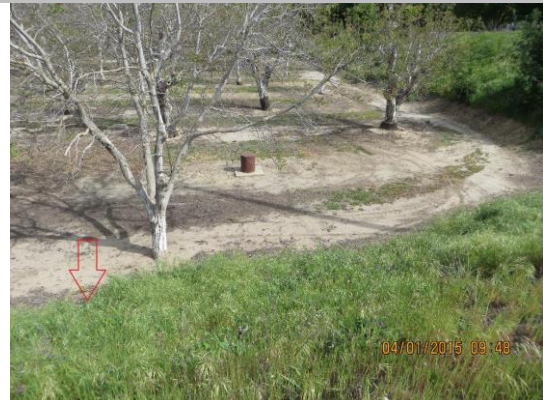
Photo 3 of 3 : UCIP_FA_2015_5831.jpg

Concrete standpipe visible on lower slope of LS toe.

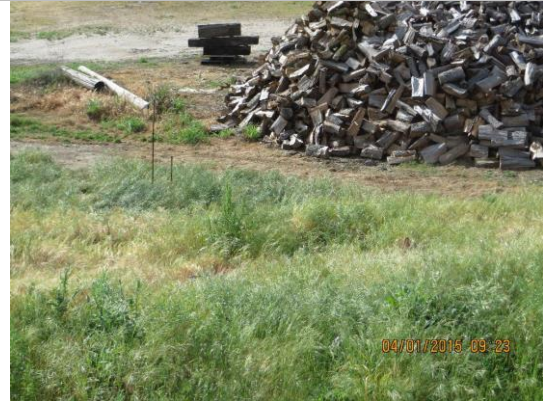
Photo 1 of 3 : UCIP_FA_2015_5984.jpg

Pipe and hose bib visible in tall grass at WS toe.

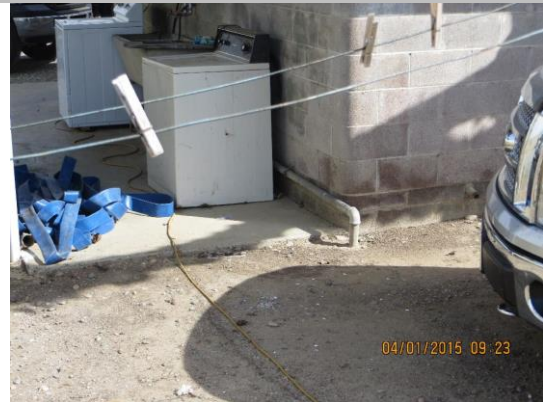
Photo 2 of 3 : UCIP_FA_2015_5985.jpg

Possible source on LS at building corner.

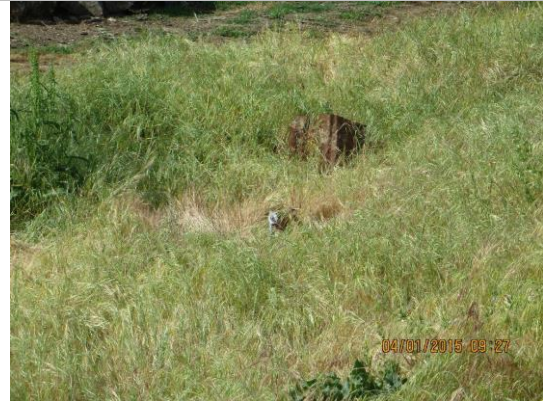
Photo 3 of 3 : UCIP_FA_2015_5986.jpg

Pipe and hose bib visible in tall grass at WS toe.

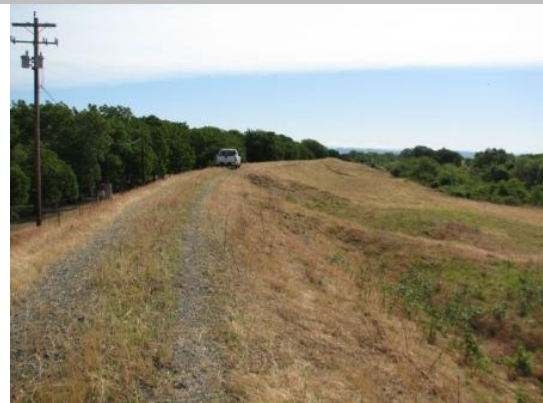
Photo 1 of 1 : FA_2015_RD0817_13_10_20151102_00004.jpg

LM Start	2.08	Rating **	U	Issue No.	10
LM End	3.18	Issue Type +	Ob	Location *	N/A
Category	Earthen Levee			GPS Latitude/Longitude	
				Start	End
Item	Slope Stability			38.989338 °	38.994124 °
				-121.468640 °	-121.449448 °
DWR ID	DWR_RD0817_02_s_2012_10				
Action/Comments					
Repair slope instability. Inspector Comments: The levee is oversteepend at this location. The LMA states that it has always been like this and the USACE did not finish constructing the levee here.

Levee mile 2.08, this photo shows the slope is less than required, this is the downstream limit of the site, this is the waterside slope.

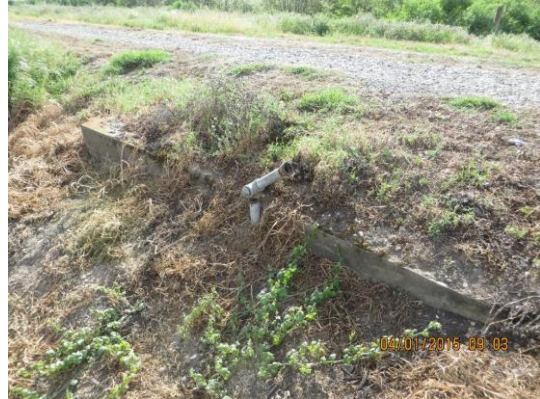
Photo 1 of 3 : UCIP_FA_2015_5837.jpg

Pipe and concrete headwall visible on LS shoulder.

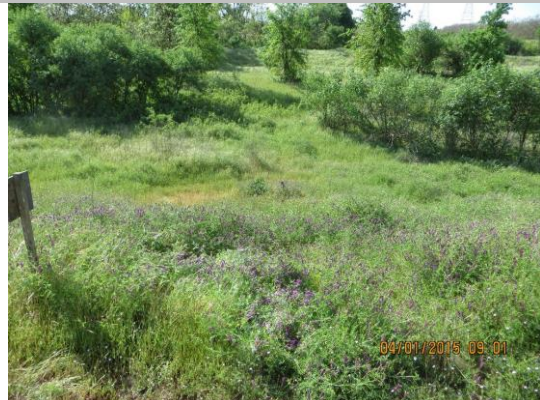
Photo 2 of 3 : UCIP_FA_2015_5838.jpg

WS slope. pipe not visible.

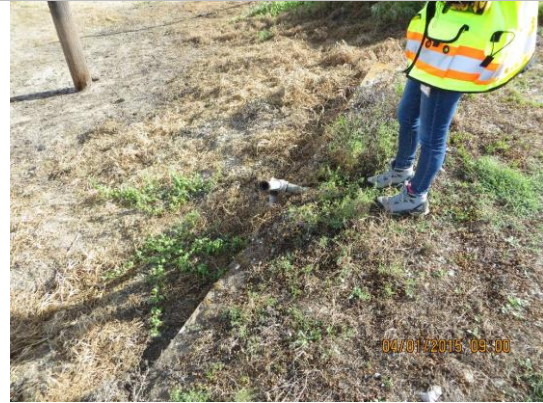
Photo 3 of 3 : UCIP_FA_2015_5839.jpg

Pipe visible on LS shoulder.

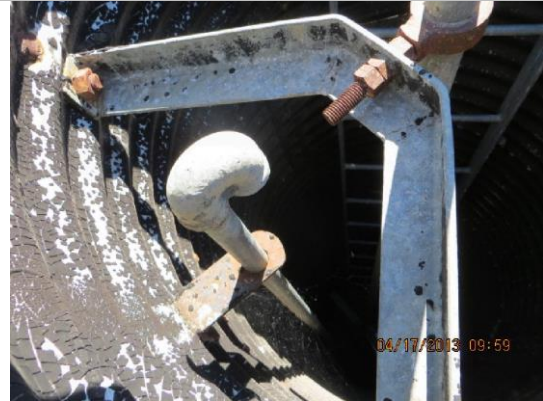
Photo 1 of 3 : UCIP_FA_2015_0240.jpg

WS- CMP riser with air vent and slide gate.

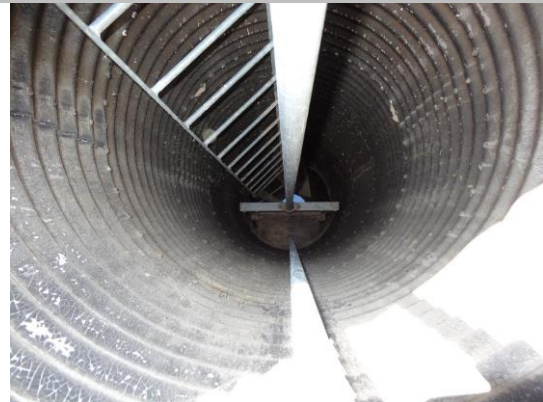
Photo 2 of 3 : UCIP_FA_2015_0241.jpg

WS- inside CMP riser with air vent and slide gate.

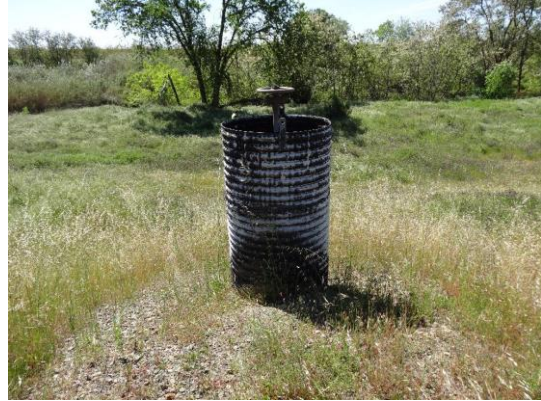
Photo 3 of 3 : UCIP_FA_2015_0242.jpg

WS- CMP riser on levee slope.

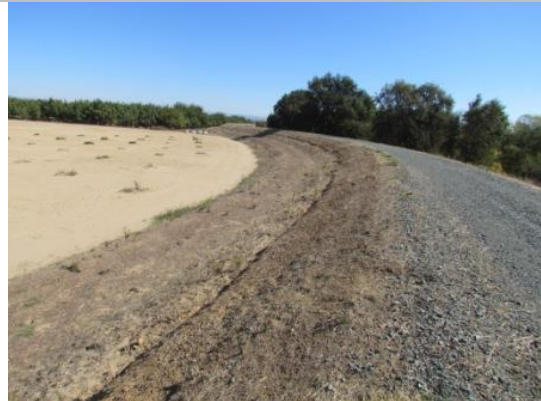
Photo 1 of 2 : FA_2015_RD0817_13_6_20151102_00002.jpg

LM Start	3.73	Rating **	U	Issue No.	6
LM End	3.83	Issue Type +	Ob	Location *	LS
Category	Earthen Levee			GPS Latitude/Longitude	
				Start	End
Item	Slope Stability			38.992656 °	38.993209 °
				-121.439508 °	-121.437772 °
DWR ID	DWR_RD0817_02_f_2013_6				
Action/Comments					
Repair slope instability. Inspector Comments: Separation line in the soil on the landward side between the clay and the sand.

This photo was taken from the crown of the levee facing east looking at the separation line in the soil on the land ward side between the clay and the sand.

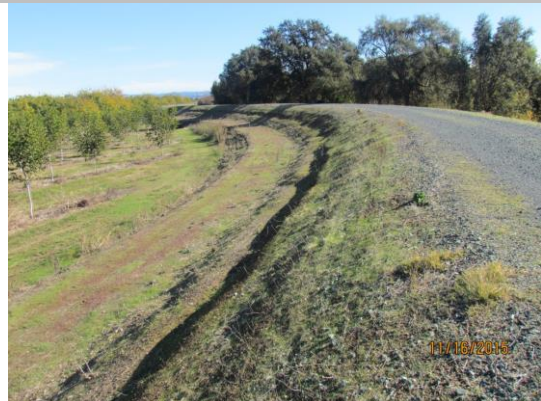
Photo 2 of 2 : FA_2015_RD0817_13_6_20151117_00008.jpg

View of the separation of soil on the landward side of the levee looking upstream. Fall 2015.

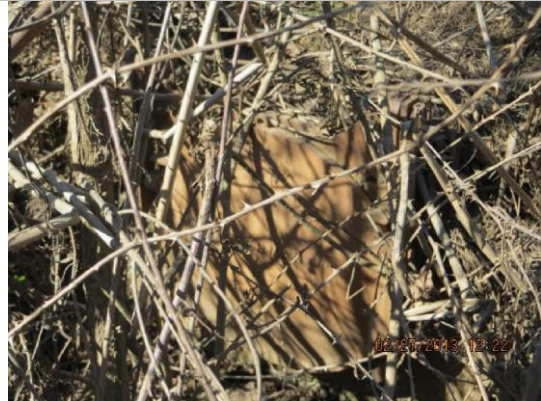
Photo 1 of 3 : UCIP_FA_2015_3481.jpg

Flap gate blocked by vegetation on WS toe.

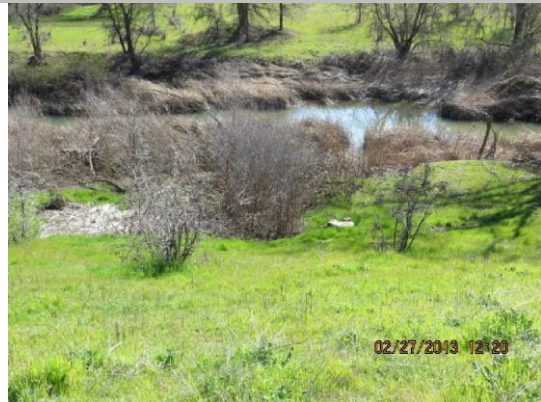
Photo 2 of 3 : UCIP_FA_2015_3482.jpg

Outlet in brush at WS toe.

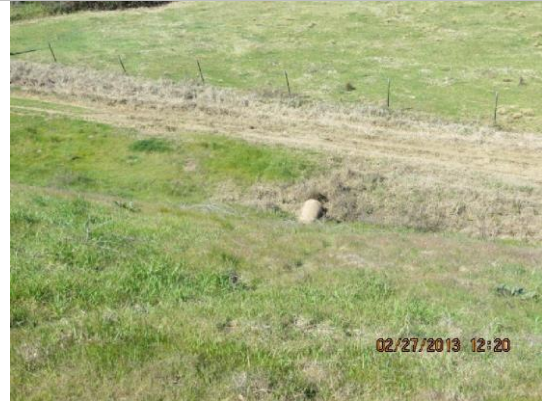
Photo 3 of 3 : UCIP_FA_2015_3483.jpg

Pipe at LS toe

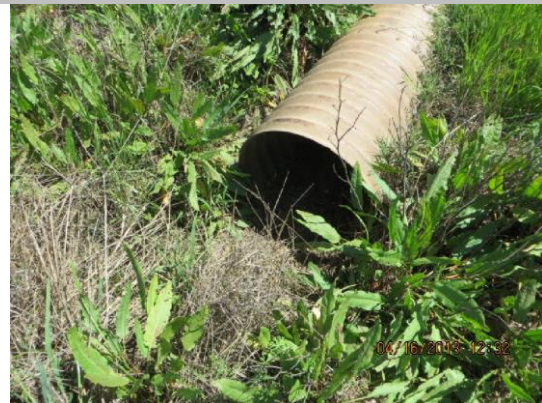
Photo 1 of 2 : UCIP_FA_2015_0243.jpg

LS- CM drainage pipe on toe of the levee.

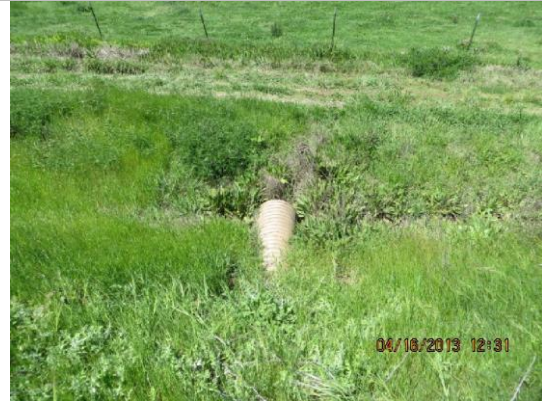
Photo 2 of 2 : UCIP_FA_2015_0244.jpg

LS- overview of CM drainage pipe on toe of the levee.

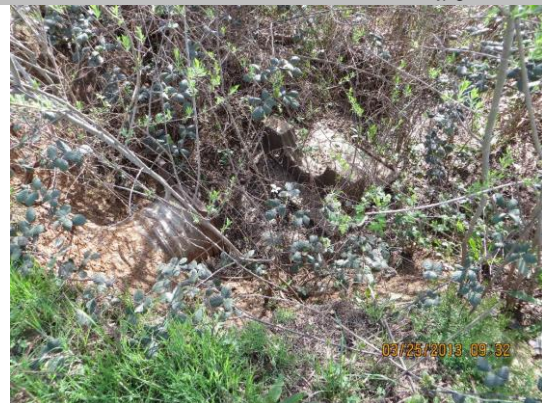
Photo 1 of 3 : UCIP_FA_2015_3294.jpg

Pipe no longer mounted to headwall at WS toe.

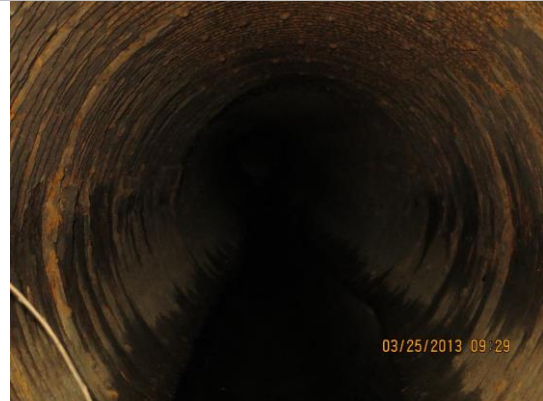
Photo 2 of 3 : UCIP_FA_2015_3295.jpg

Pipe Heavily corroded throughout

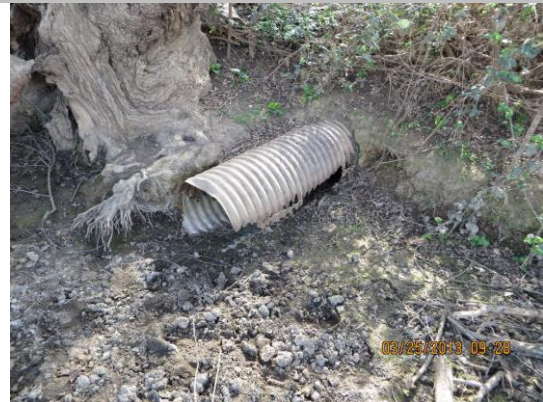
Photo 3 of 3 : UCIP_FA_2015_3296.jpg

Pipe on LS toe corroded through.

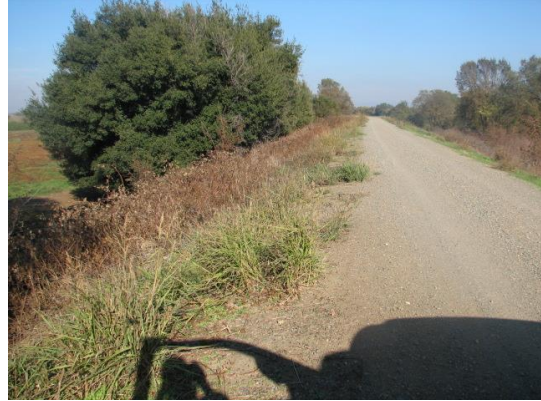
Photo 1 of 1 : FA_2015_RD0817_14_8_20151102_00001.jpg

Levee mile 0.54, the landside slope.

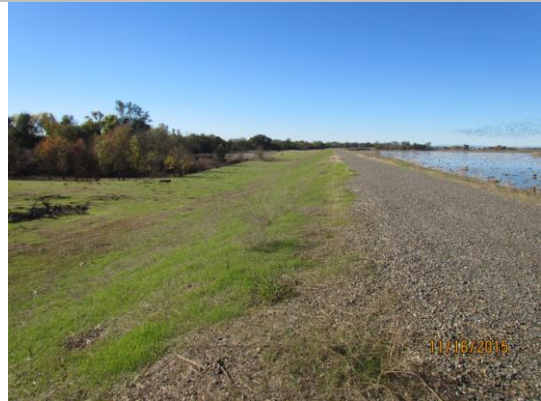
Photo 1 of 1 : FA_2015_RD0817_14_18_20151117_00013.jpg

View of the vegetation on the waterward side of the levee looking downstream. Fall 2015.

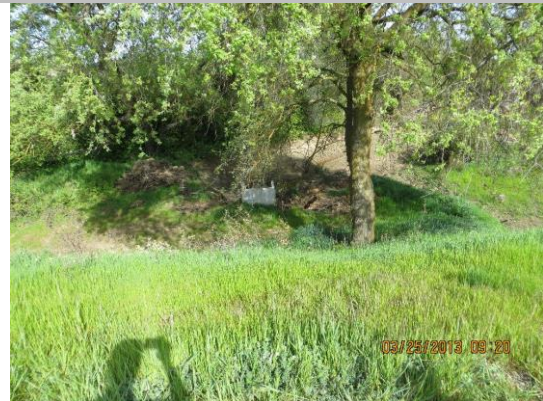
Photo 1 of 3 : UCIP_FA_2015_2942.jpg

Improved concrete inlet on LS toe.

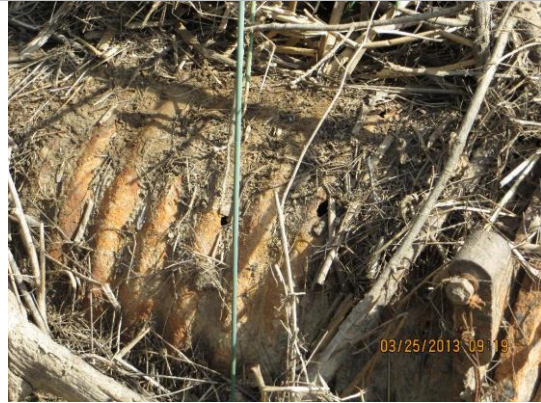
Photo 2 of 3 : UCIP_FA_2015_2943.jpg

Holes in pipe at broken flapgate on WS toe.

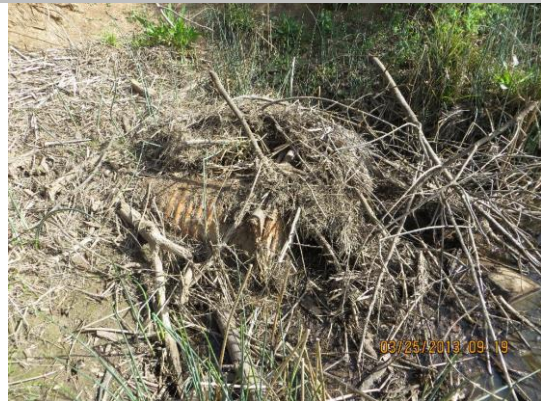
Photo 3 of 3 : UCIP_FA_2015_2944.jpg

Pipe and flapgate at WS toe blocked by debris.

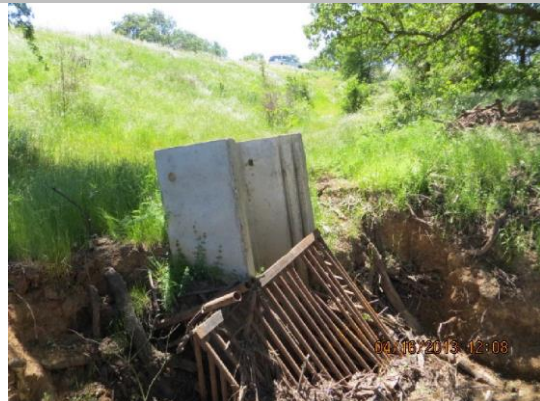
Photo 1 of 3 : UCIP_FA_2015_0839.jpg

LS- half box concrete outlet structure with trash rack.

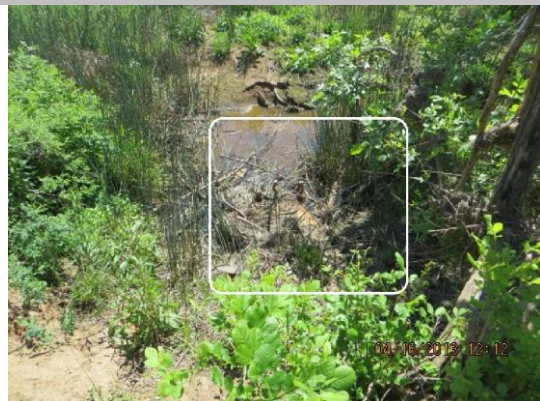
Photo 2 of 3 : UCIP_FA_2015_0840.jpg

WS- overview of CM pipe, flap gate and debris.

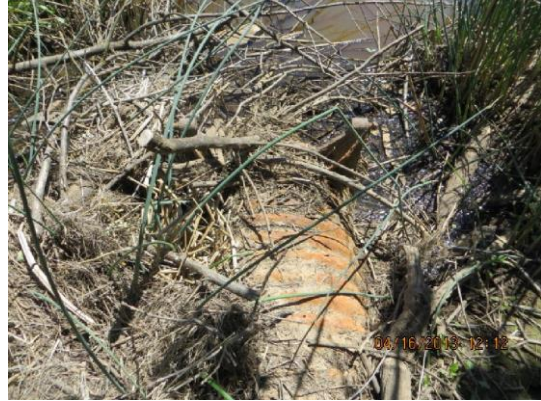
Photo 3 of 3 : UCIP_FA_2015_0841.jpg

WS- CM pipe, flap gate and debris.

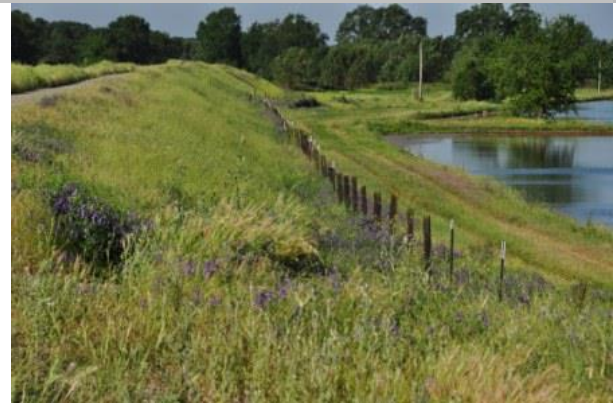
Photo 1 of 1 : FA_2015_RD0817_14_15_20151102_00007.jpg

Wire fence along L/S toe.

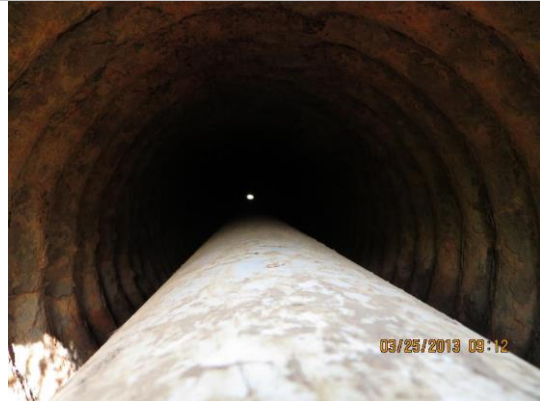
Photo 1 of 3 : UCIP_FA_2015_2945.jpg

Pipe heavily corroded throughout.

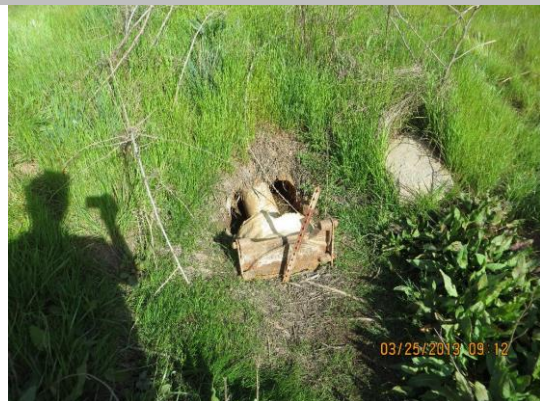
Photo 2 of 3 : UCIP_FA_2015_2946.jpg

Pipe cut behind flap gate on WS toe with 8-inch PVC.

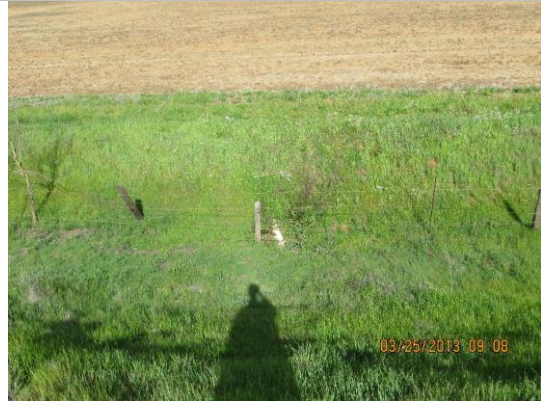
Photo 3 of 3 : UCIP_FA_2015_2947.jpg

Pipe on LS toe with 8-inch PVC pipe sticking out.

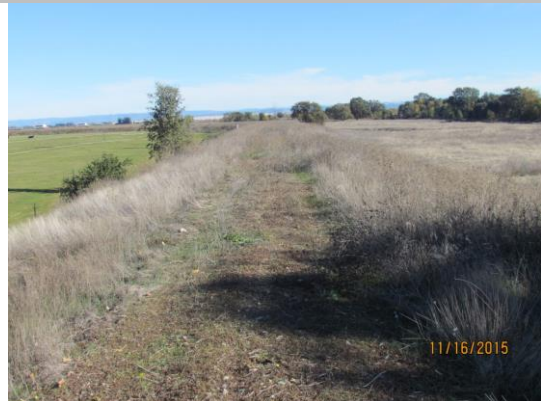
Photo 1 of 1 : FA_2015_RD0817_14_14_20151117_00014.jpg

View of the vegetation on the crown of the levee looking upstream. Fall 2015.

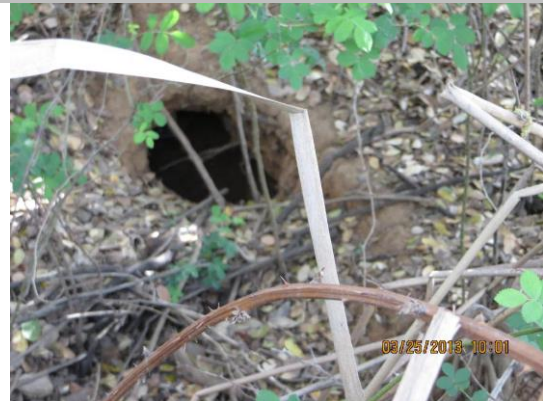
Photo 1 of 3 : UCIP_FA_2015_2948.jpg

Sinkhole or animal burrow over pipe on LS toe.

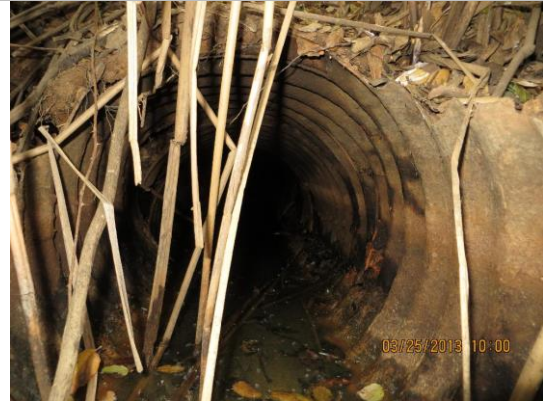
Photo 2 of 3 : UCIP_FA_2015_2949.jpg

Pipe at inlet on LS toe.

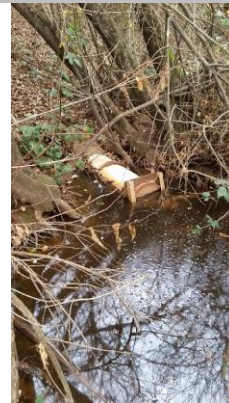
Photo 3 of 3 : UCIP_FA_2015_4403.jpg

WS drainage outlet with flap gate. Steel pipe is sleeved within heavily rusted CM pipe near daylight to embankment
